Flood Watch

Far North District

Winisk River

Friday, May 22, 2026
3:10 pm

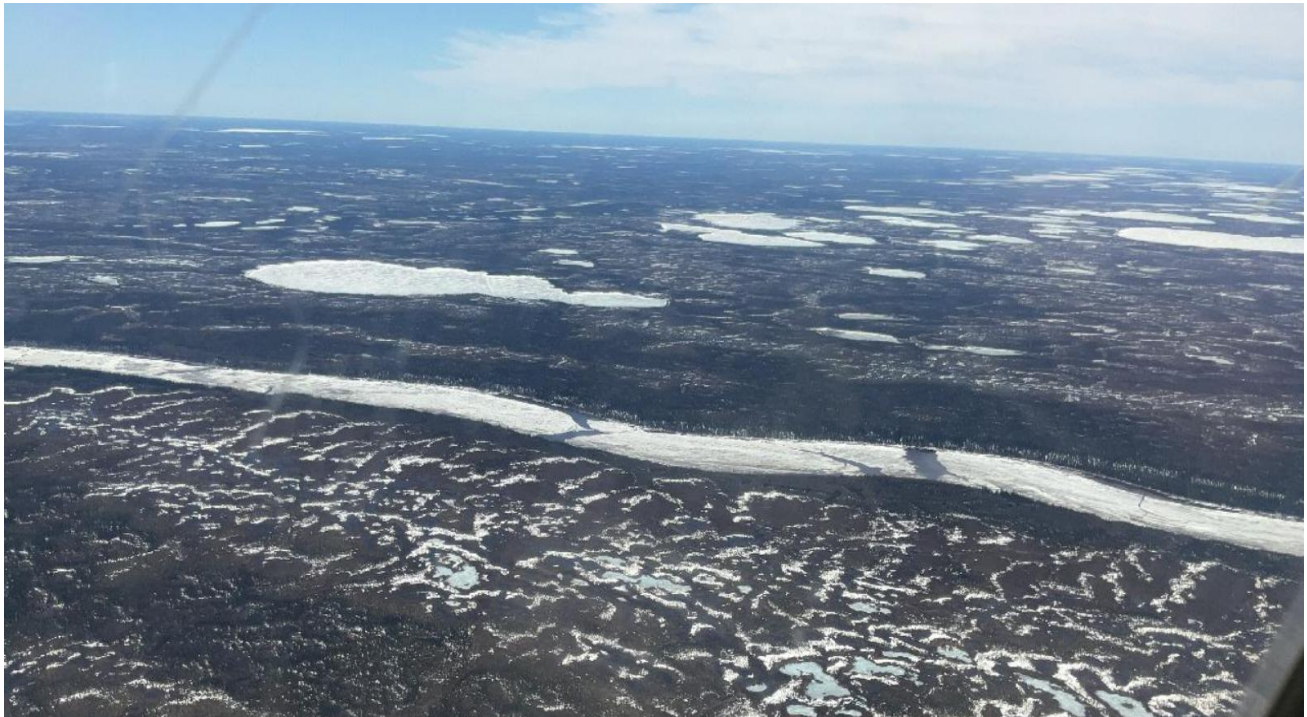
The MNR conducted a surveillance flight of the Winisk River today, commencing in the headwaters at the Asheweig River at Straight Lake stream gauge location and continuing down to the mouth of the Winisk River at Hudson Bay. The upper reaches of the Winisk River largely consists of deteriorated ice cover, minor expanses of open water and intermittent areas of rubble ice. Water levels are elevated as indicative of the stream gauge graphs and verified by the aerial observations of major shoreline separation and ice fractures (see photo below).

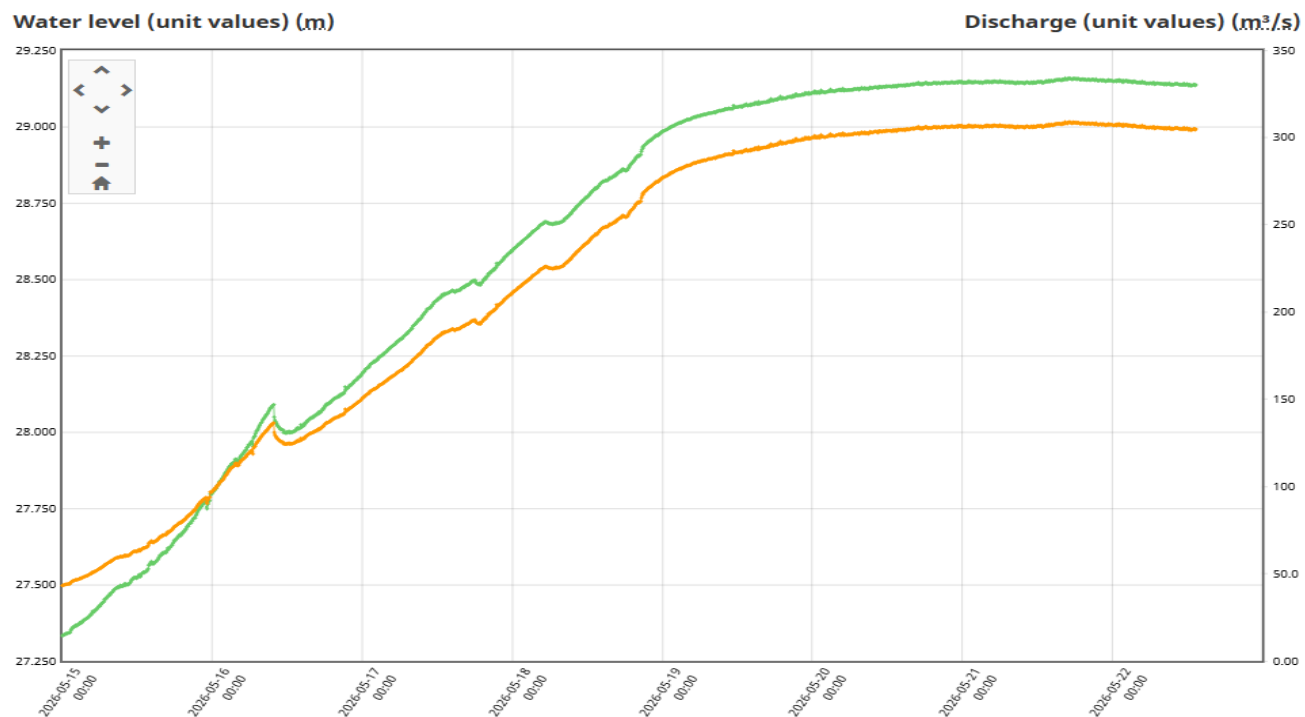
Winisk River Shamattawa River tributary

Shamattawa River at outlet of Shamattawa Lake tributary stream gauge station data (graph) image captured at 1:40pm.

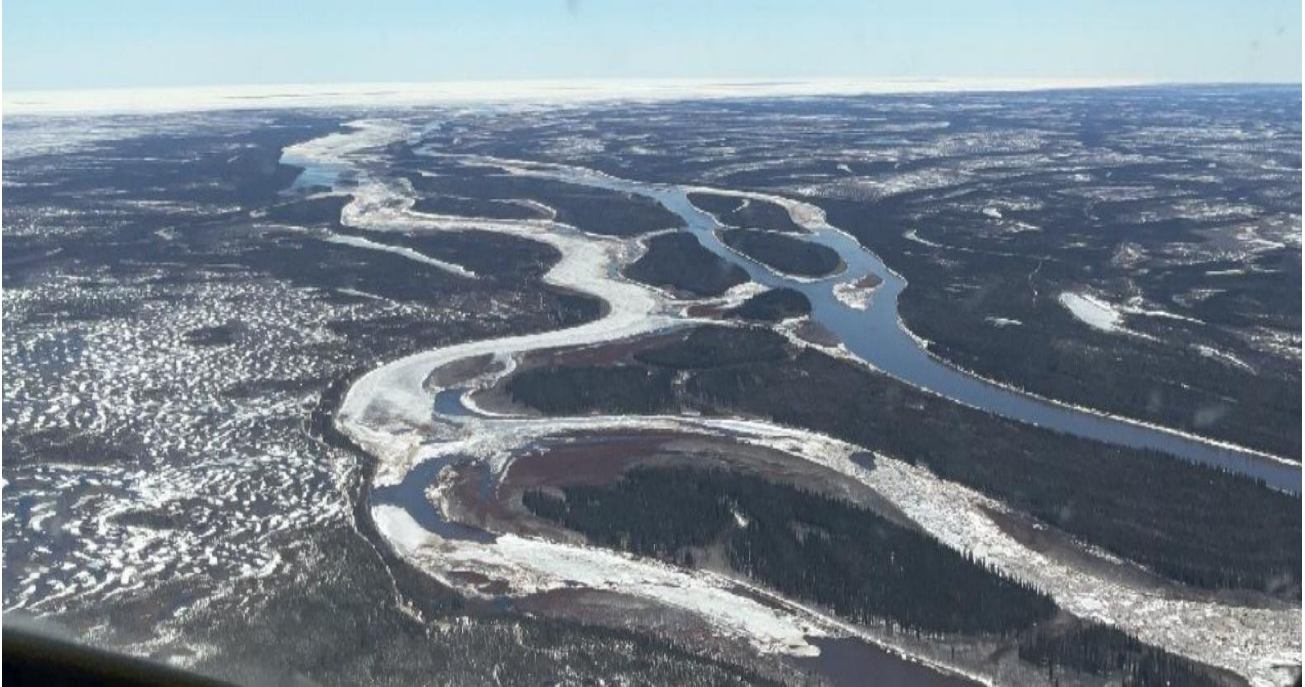
Further downriver closer to the community of Peawanuck, the remaining ice cover had broken up, forming a large expanse of open water and rubble ice likely triggered by the Shamattawa River tributary that flows into the Winisk River on the opposite bank from Peawanuck. In this expanse of the Winisk River, there are several ice jams (albeit minor) adjacent to large expanses or channels of open water (see photo below).

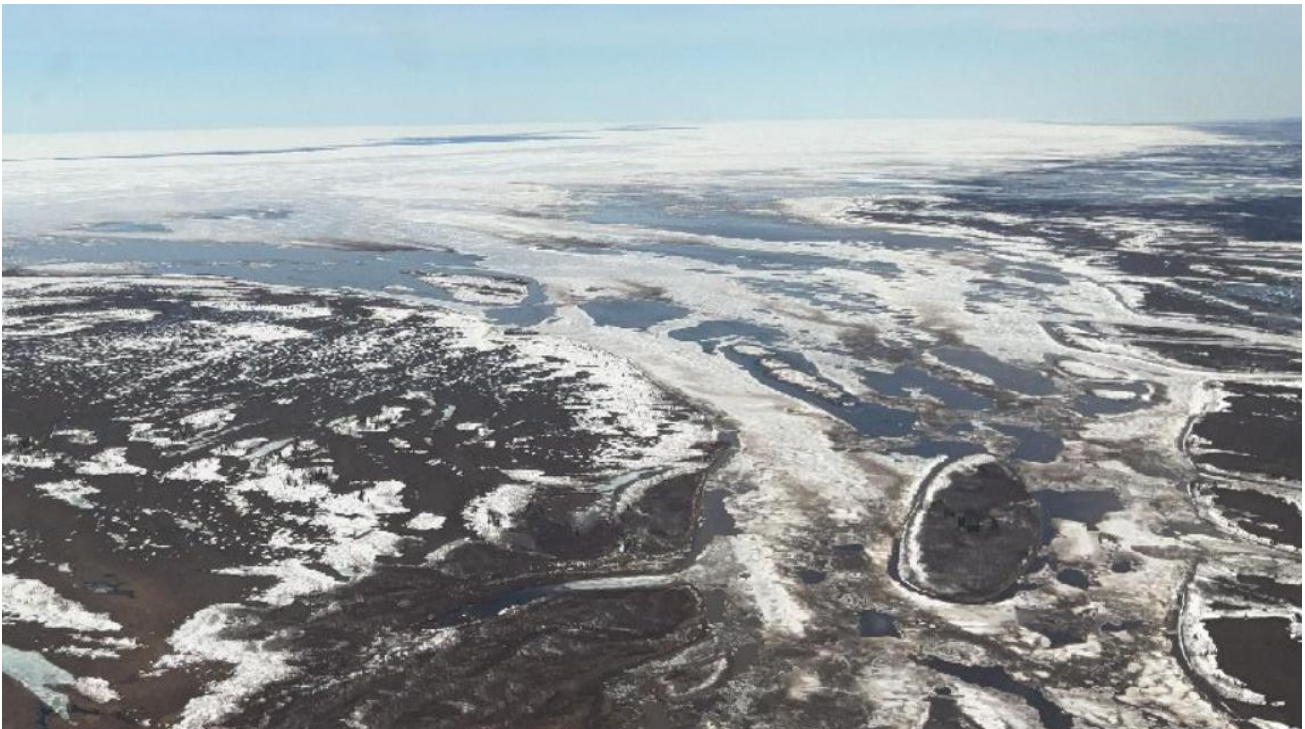
Ice conditions near the mouth of the Winisk River appears substantially deteriorated and not hindering the Winisk River from flowing into Hudson Bay.

Above photo depicts the mouth of the Winisk River, flowing into Hudson Bay.
